Manhole Inspection Summary

Manhole # S31CC_022MH

Insp Date: 1/31/07 11:14 AM

Location Address: **1000 MADISON ST**

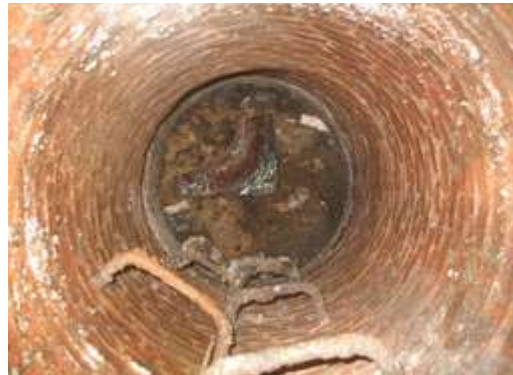
Top View

Corroded steps. Evidence of surcharge - Bench debris.

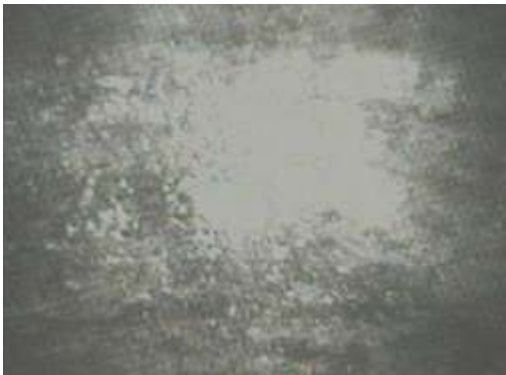
Defect

Barrel infiltration.

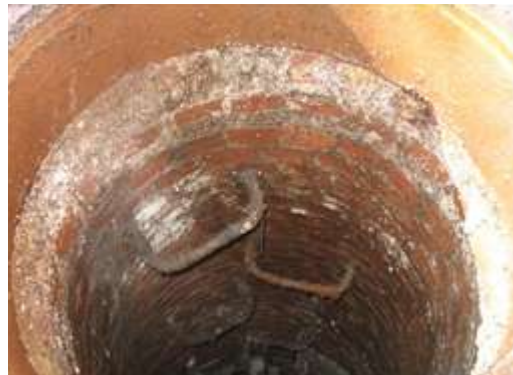
Defect

Frame leaks. Adjustment deterioration and infiltration.

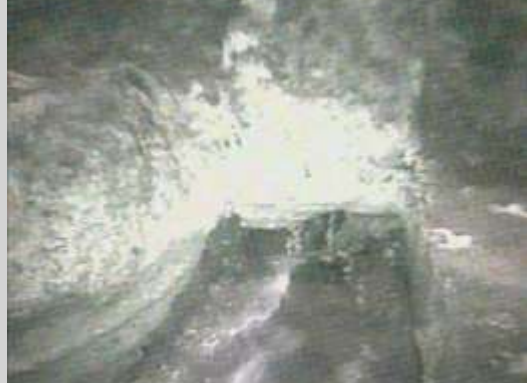
8 in. Circular Gravity Sewer Pipe Out @ 12 O'Clock

Deposits: ☐ None ☐ Mud ☐ Sludge ☐ Debris ☒ **Grease**

Silt Depth: **0** (in.) Deposits Extent: **Light**

Infiltration: **Evidence** Pipe Seal Cond: **Roots**

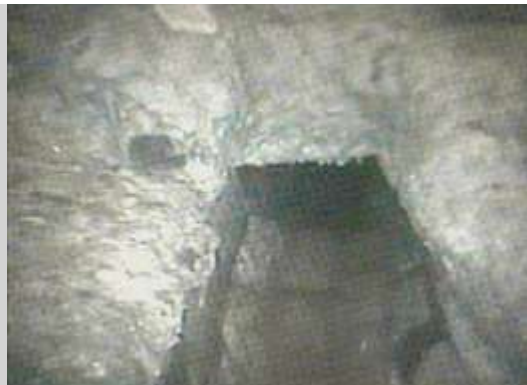
8 in. Circular Gravity Sewer Pipe In @ 9 O'Clock

Deposits: ☐ None ☐ Mud ☐ Sludge ☐ Debris ☒ **Grease**

Silt Depth: **0.5** (in.) Deposits Extent: **Light**
